INDOOR AIR QUALITY ASSESSMENT

**Waterford Street School
62 Waterford Street
Gardner, Massachusetts**

Prepared by:
Massachusetts Department of Public Health
Center for Environmental Health
Bureau of Environmental Health Assessment
Emergency Response/Indoor Air Quality Program
June 2004

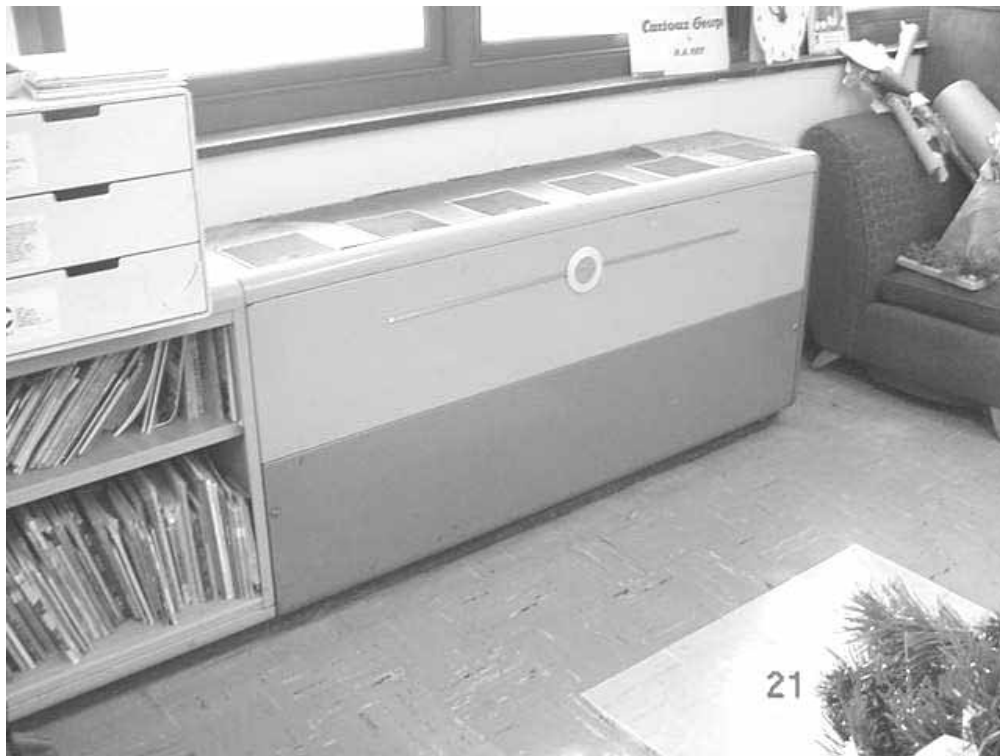
Picture 1

Fresh air in classrooms is supplied by a unit ventilator (univent) system ([Picture 1](#)). Univents are designed to draw air from outdoors through a fresh air intake located on the exterior walls of the building and return air through an air intake located at the base of each unit (Figure 1). Fresh and return air are mixed, filtered, heated and provided to classrooms through a fresh air diffuser located in the top of the unit. Obstructions to airflow, such as papers and books stored on univents and bookcases, carts and desks placed in front of univent returns were noted (Picture 2). In order for univents to provide fresh air as designed, intakes must remain free of

Typical Classroom Univent 1950's Vintage

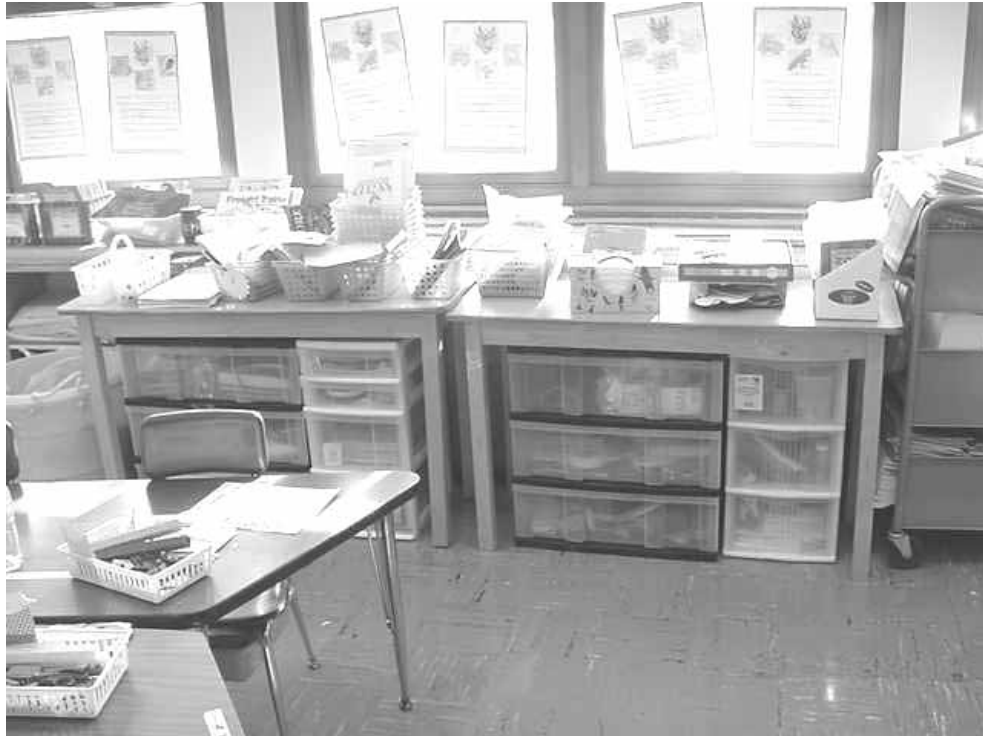
Picture 2

Univent Return Vent Obstructed by Various Items

2. Remove all blockages from univents and exhaust vents to ensure adequate airflow.

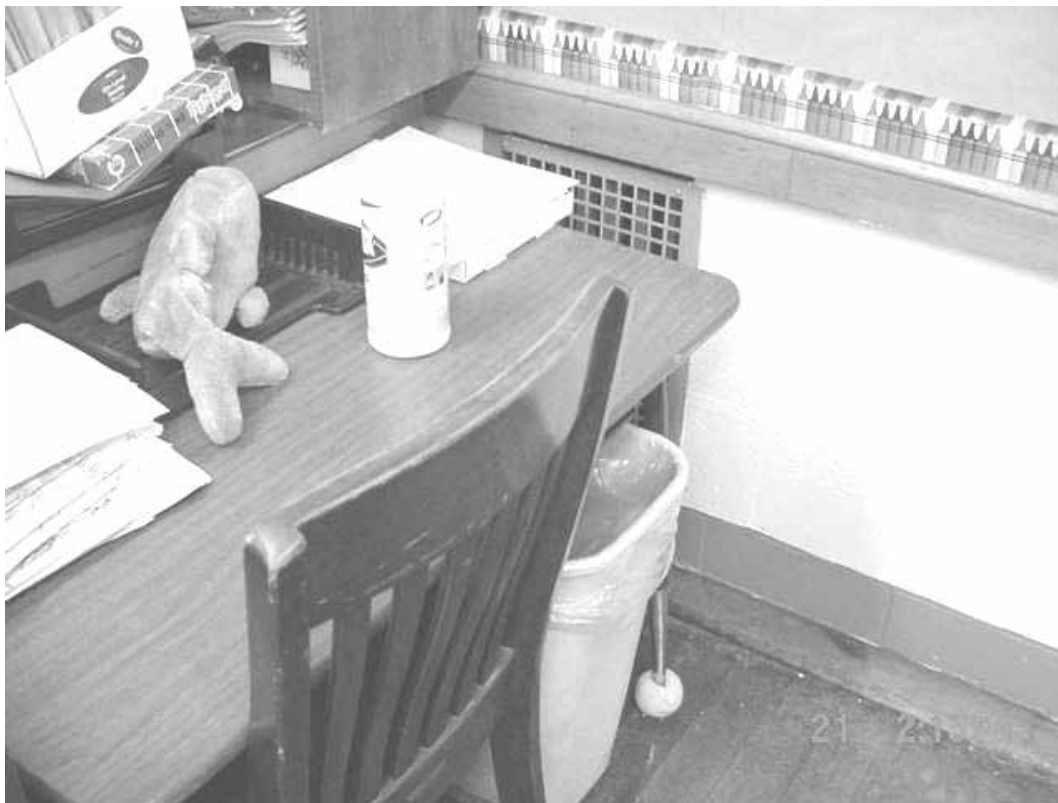
Picture 3

Exhaust ventilation in classrooms is provided by a mechanical system. The exhaust system in each classroom consists of ducted, grated wall vents. Rooftop motors create flow, which aids exhausting of classroom air. A number of the exhaust vents were blocked by furniture and other items (Picture 3). As with the univents, in order to function properly, exhaust vents must remain free of obstructions.

Classroom Exhaust Vent Obstructed by Table and Other Items

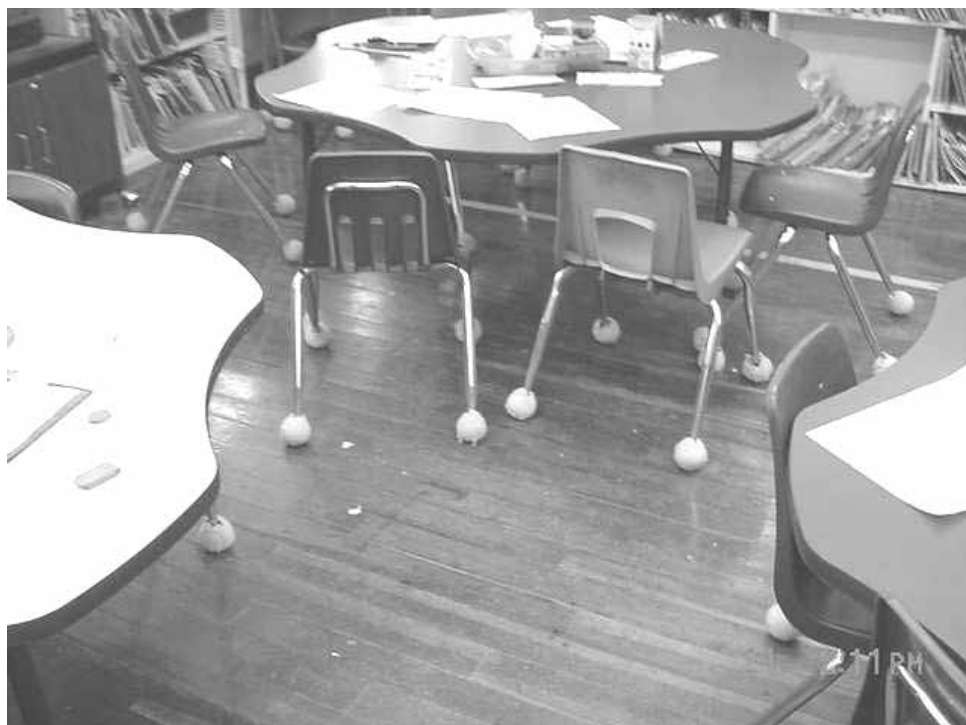
Picture 4

In an effort to reduce noise from sliding chairs, tennis balls had been sliced open and placed on chair legs (Picture 4). Tennis balls are made of a number of materials that are a source of respiratory irritants. Constant wearing of tennis balls can produce fibers and to off-gas TVOCs. Tennis balls are made with a natural rubber latex bladder, which becomes abraded when used as a chair leg pad. Use of tennis balls in this manner may introduce latex dust into the school environment. Some individuals are highly allergic to latex (e.g., spina bifida patients) (SBAA, 2001). It is recommended that the use of materials containing latex be limited in buildings to reduce the likelihood of symptoms in sensitive individuals (NIOSH, 1997). A question and answer sheet concerning latex allergy is attached as [Appendix B](#) (NIOSH, 1998).

Tennis Balls on Chair Legs

7. Store cleaning products properly and out of reach of students.
8. Seal utility holes in the main office and in univent cabinet interiors.
9. Consider discontinuing the use of tennis balls on chairs to prevent latex dust generation.

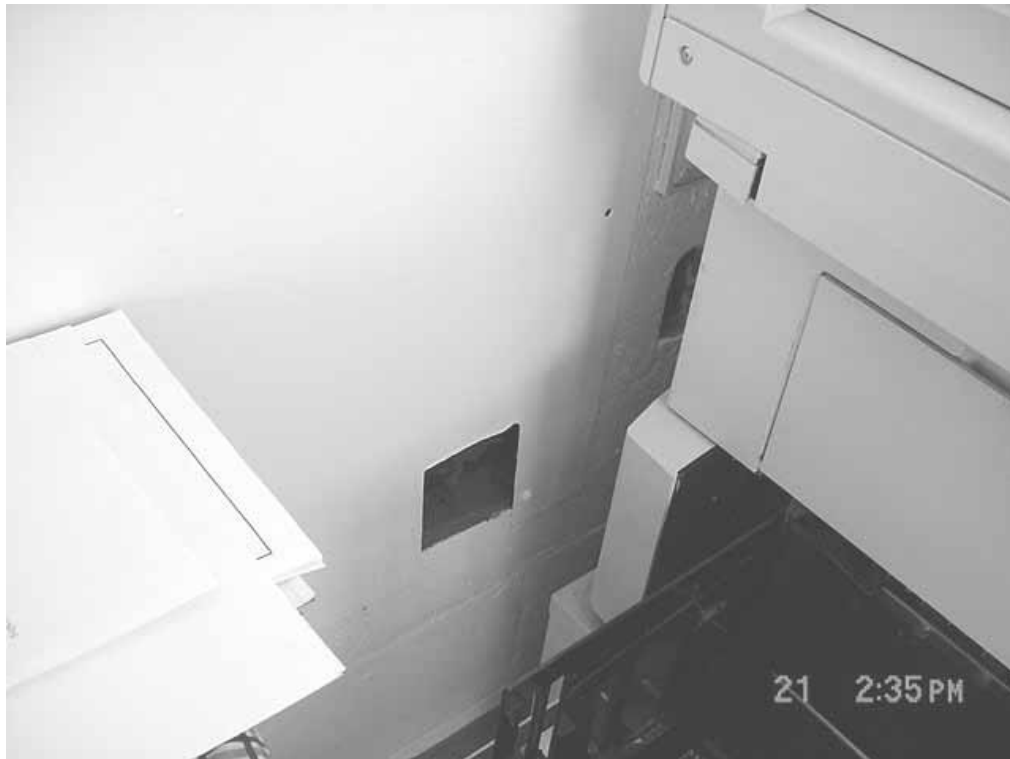
Picture 5

Finally, an open utility hole in the wall of the main office and open utility holes in floors of univents were observed (Pictures 5 and 6). Open utility holes can provide a pathway for the movement of drafts, dusts and particulate matter between rooms and floors.

Open Hole in Wall (Main Office) Near Photocopier

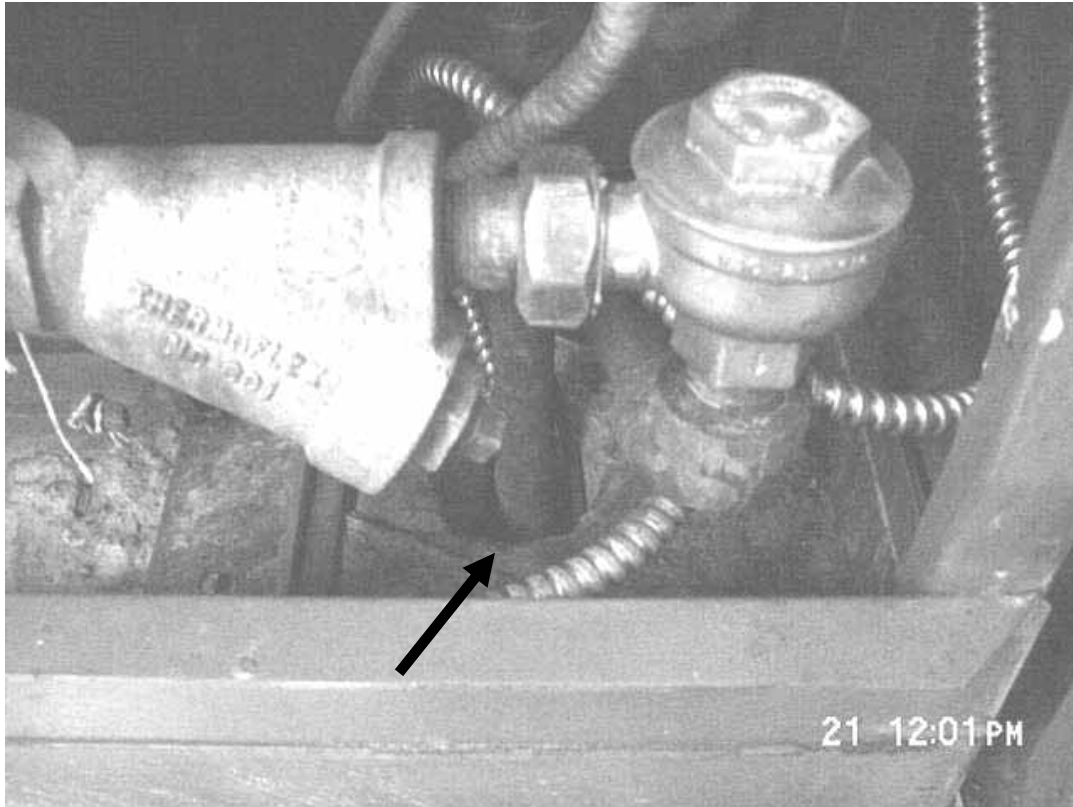
Picture 6

Open Utility Hole in Floor of Univent Cabinet
